**CONSENT ORDER
ISSUED UNDER THE
WATER POLLUTION CONTROL ACT
WEST VIRGINIA CODE, CHAPTER 22, ARTICLE 11**

TO: MarkWest Liberty Midstream & Resources, L.L.C. DATE: March 28, 2019
Gregory Bezdek, SVP, NE Region
4600 J Barry Ct. Ste 500
Canonsburg, PA 15317 ORDER NO.: 8945

MARKWEST LIBERTY MIDSTREAM & RESOURCES, L.L.C, WVR311004, Sherwood to Mobley
20" NGL, 8/22 & 8/23/2018

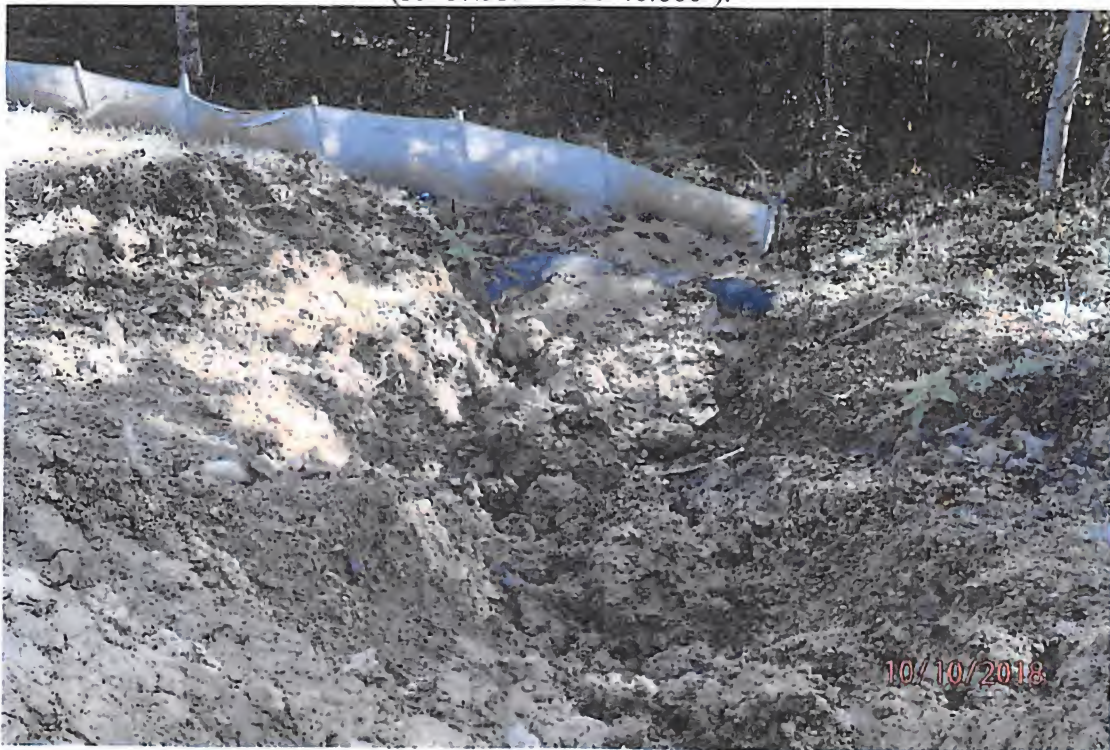
BMP in need of maintenance that resulted in CNA in UNT Righthand Fork of Morgans Run (UNT 2) (39°17.932' X 80°40.600').

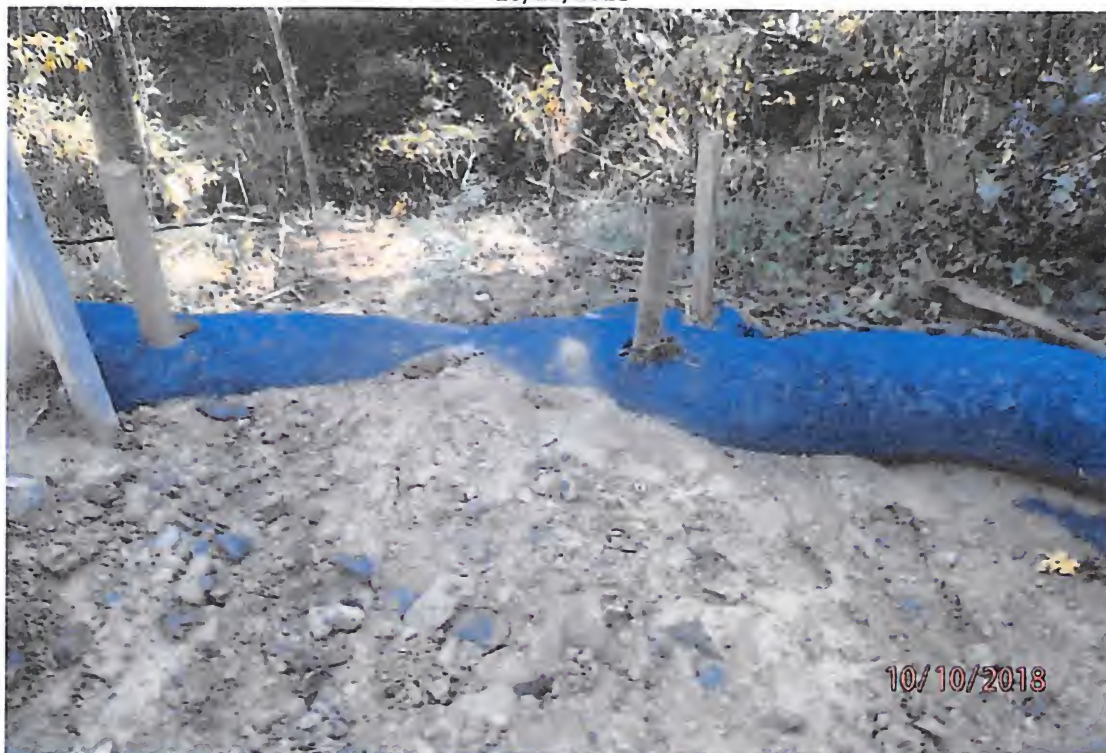
BMP in need of maintenance that resulted in CNA in UNT Righthand Fork of Morgans Run (UNT 2) (39°17.932' X 80°40.600').

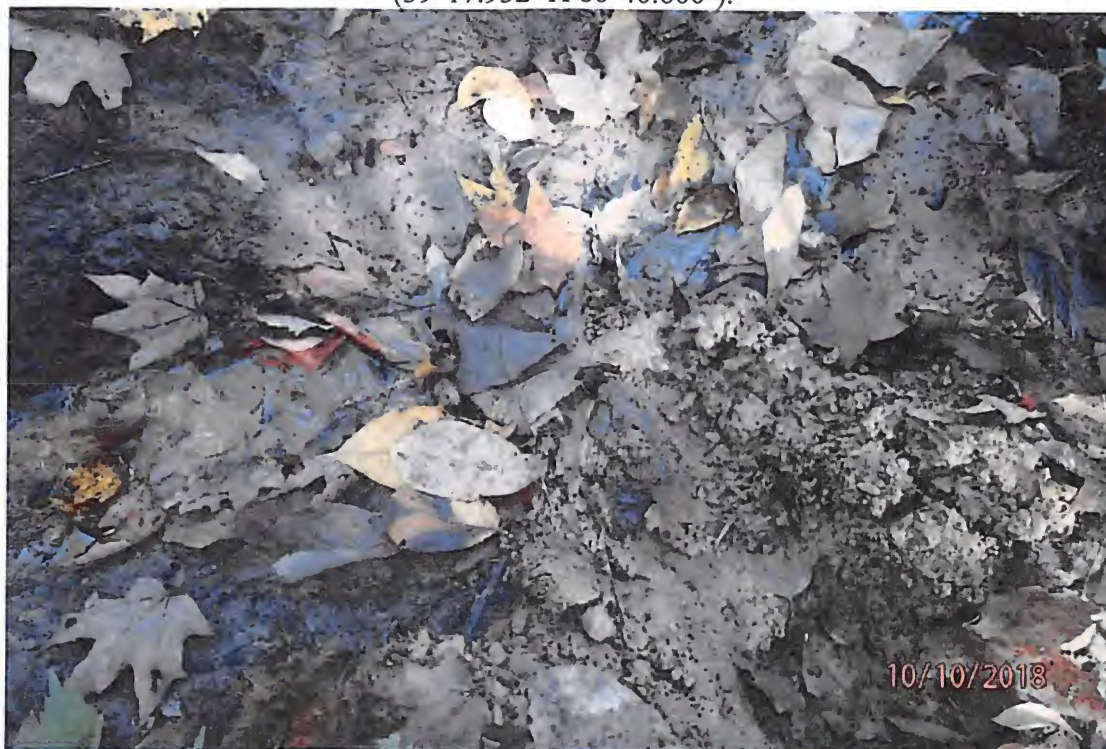
Offsite CNA deposits in UNT Righthand Fork of Morgans Run (UNT 2) (39°17.932' X 80°40.600').

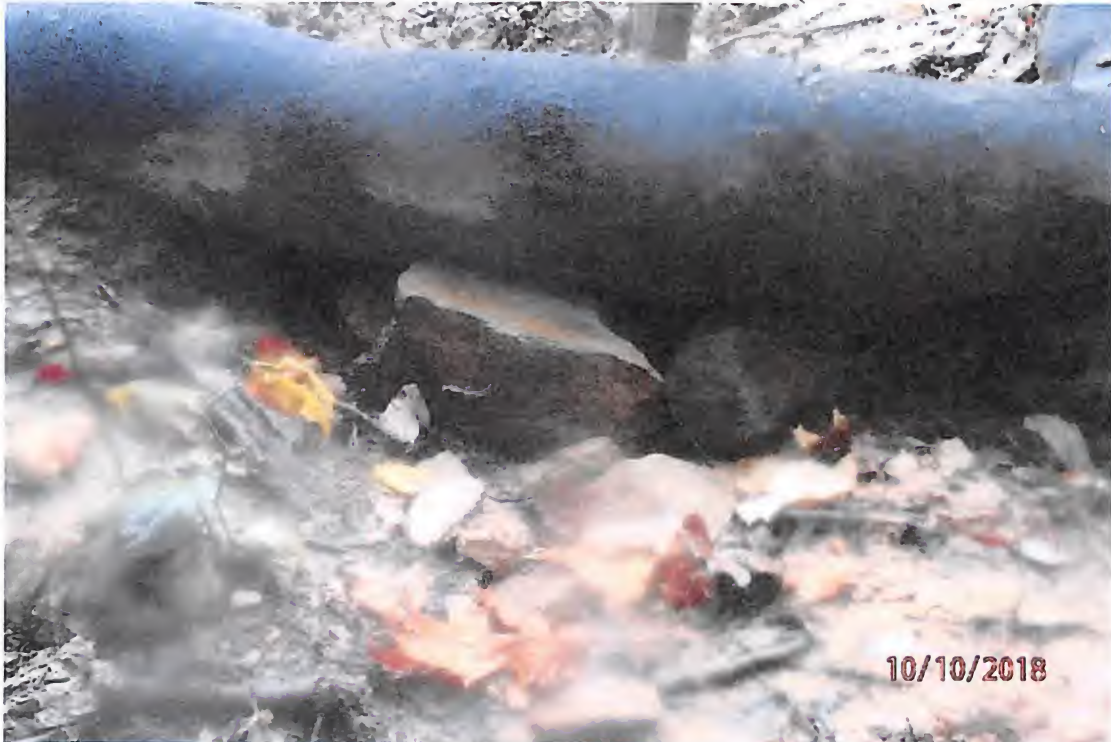
Downslope view of above pictured BMP showing rocks that have been placed in an area where sediment laden water is bypassing the BMP in an attempt to plug the area of bypass.

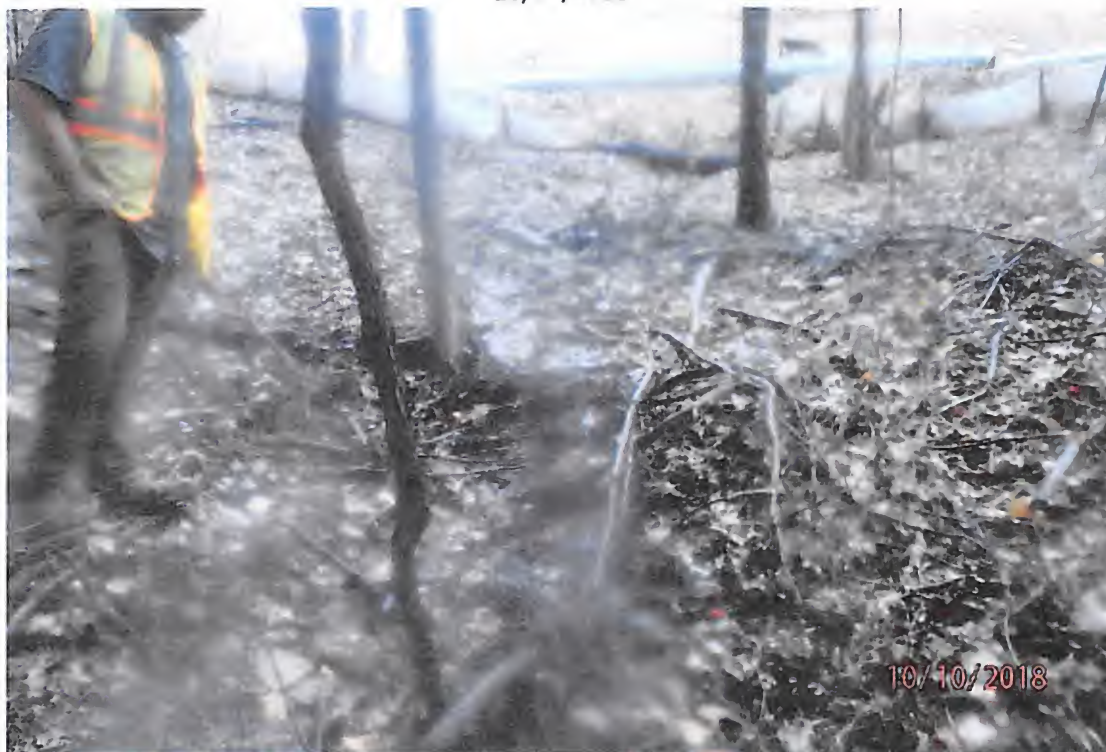
UNT Flint Run downslope of the BMP in need of maintenance.

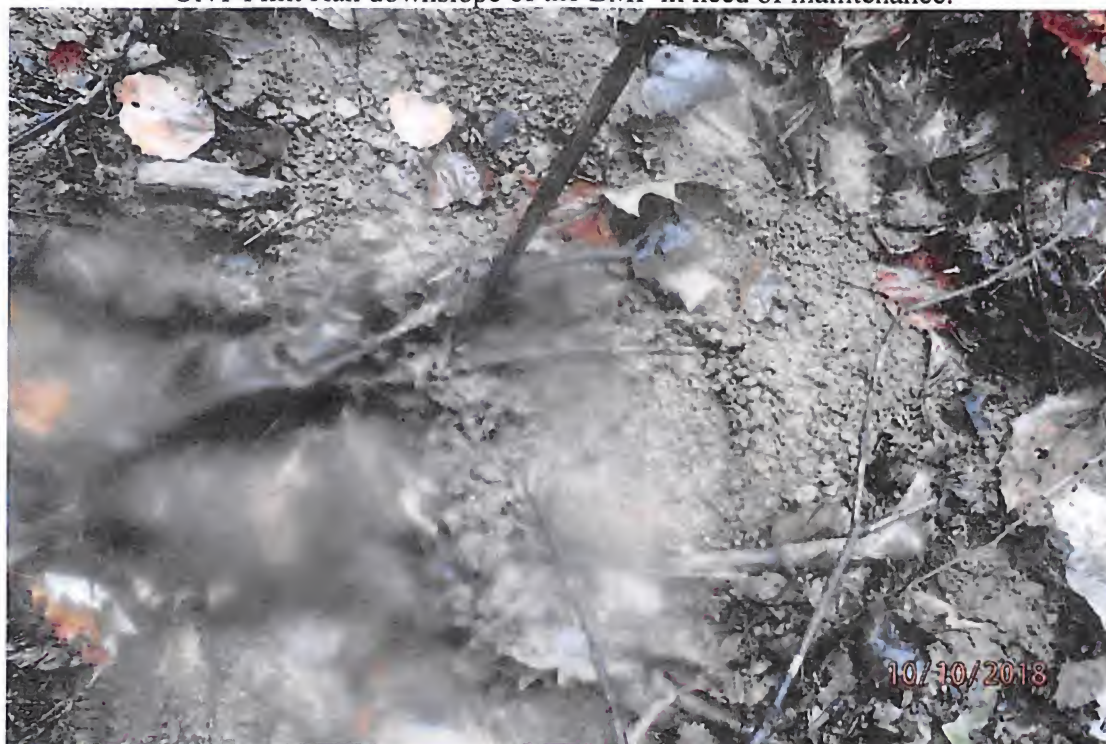
Offsite CNA deposits in UNT Flint Run (39°21.223' X 80°39.649') as a result of the previously pictured BMP.

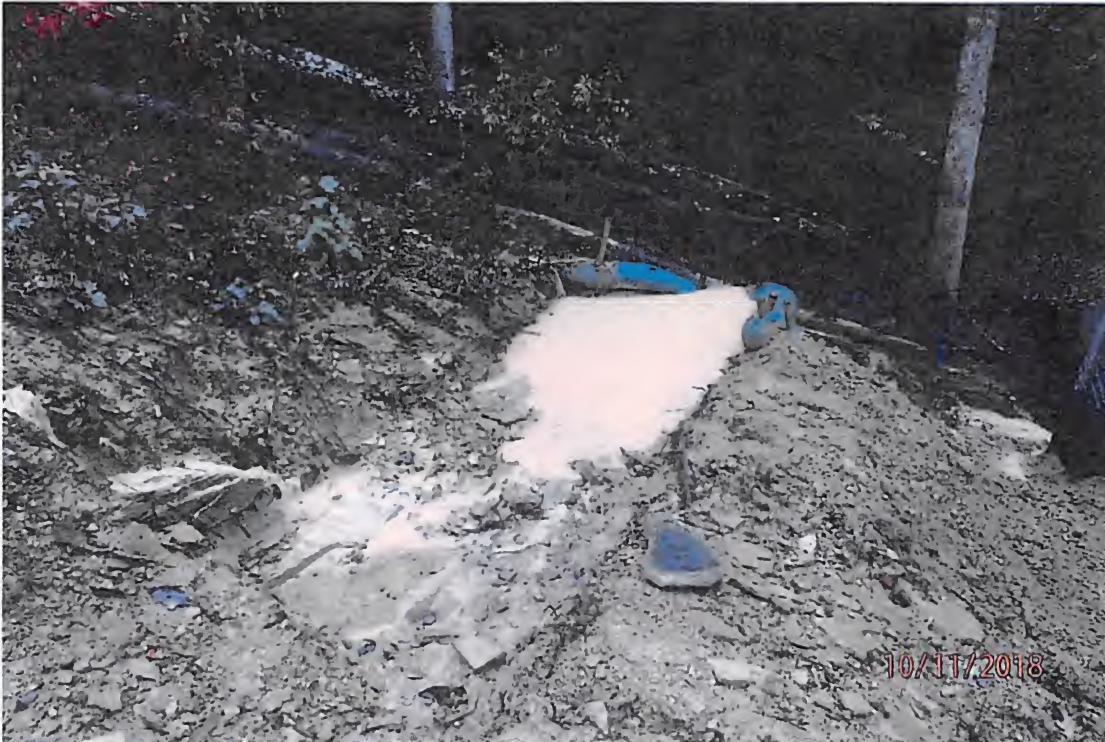
Sediment laden water bypassing an unmaintained and poorly operated water bar terminus BMP adjacent to UNT Franks Run (39°25.922' X 80°37.079').

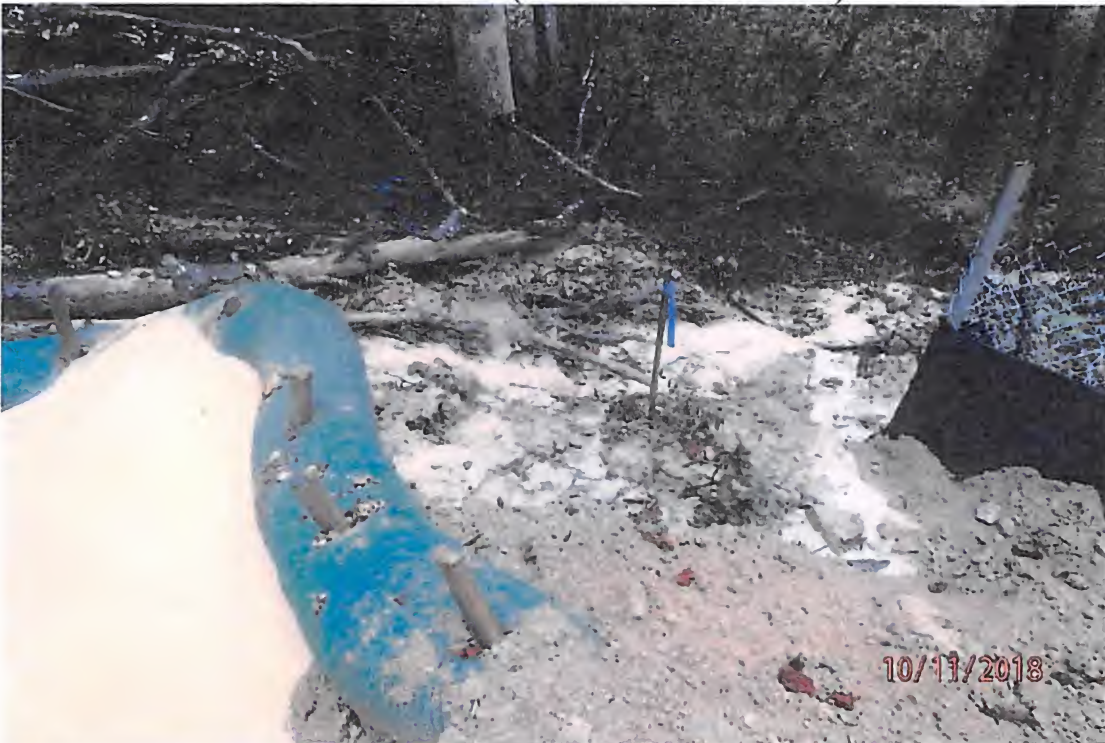
Sediment laden water bypassing an unmaintained and poorly operated water bar terminus BMP adjacent to UNT Franks Run (39°25.922' X 80°37.079').

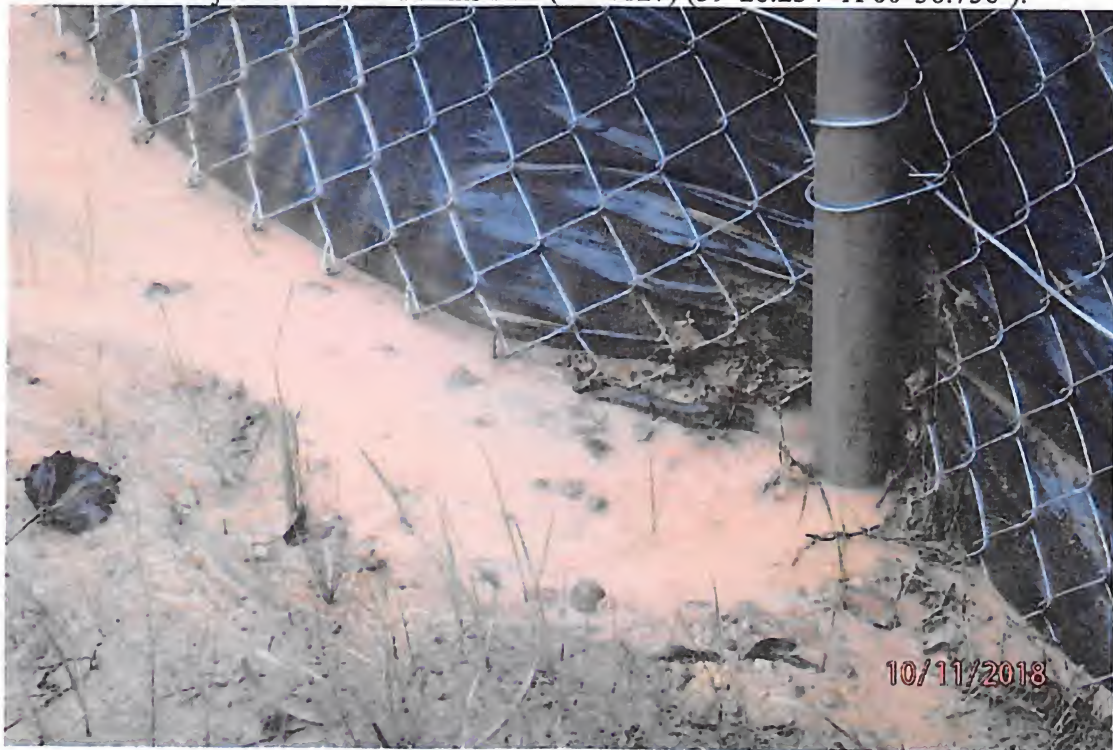
Perimeter controls in need of maintenance that are allowing sediment laden water to bypass under the device adjacent to UNT Franks Run (UNT127) (39°26.234' X 80°36.756').

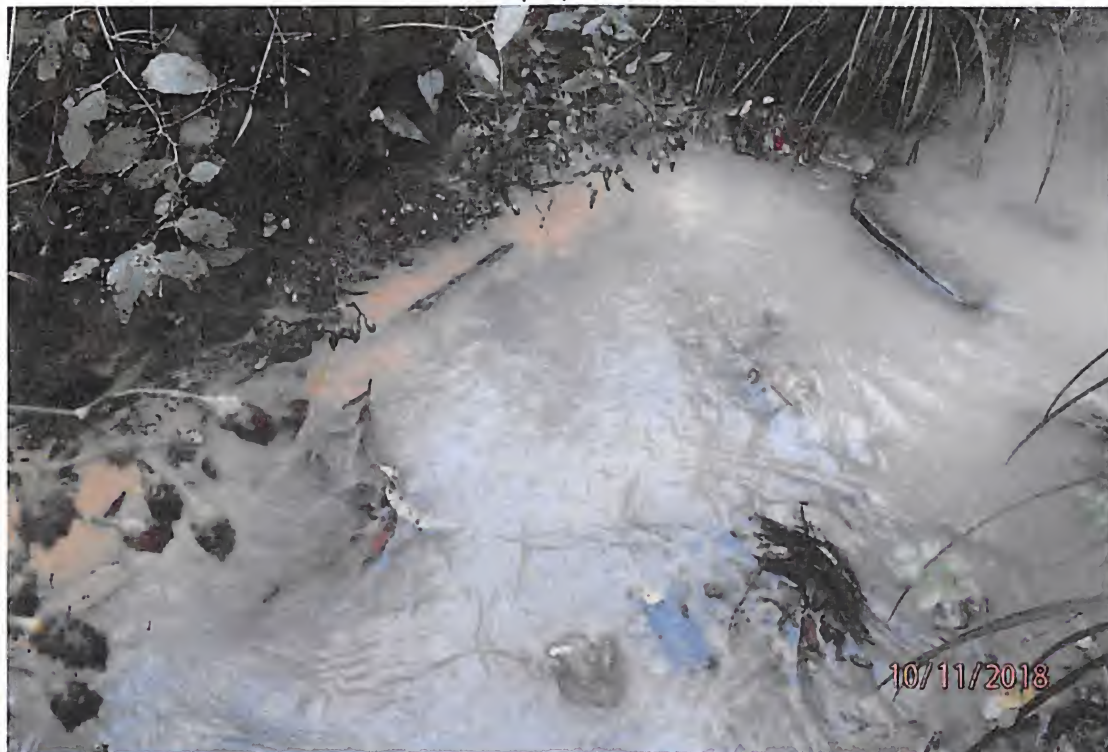
Offsite CNA distinctly visible settleable solids in UNT Franks Run (UNT127) (39°26.234' X 80°36.756').

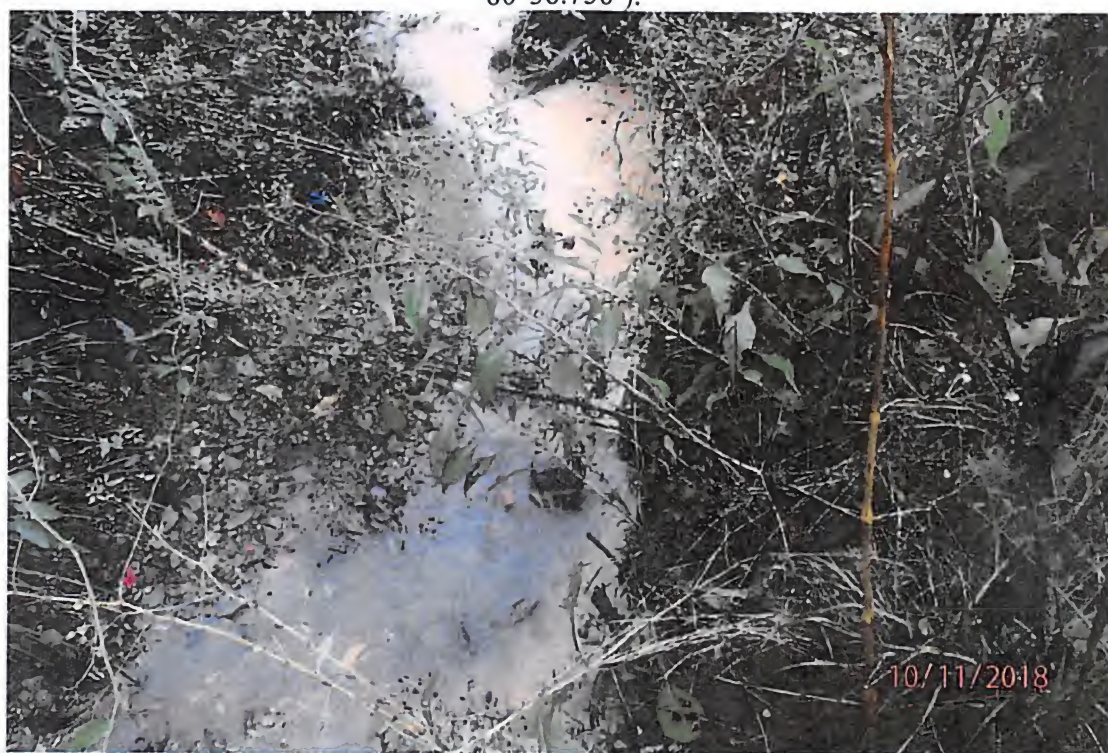
Offsite CNA distinctly visible settleable solids in UNT Franks Run (UNT127) (39°26.234' X 80°36.756').

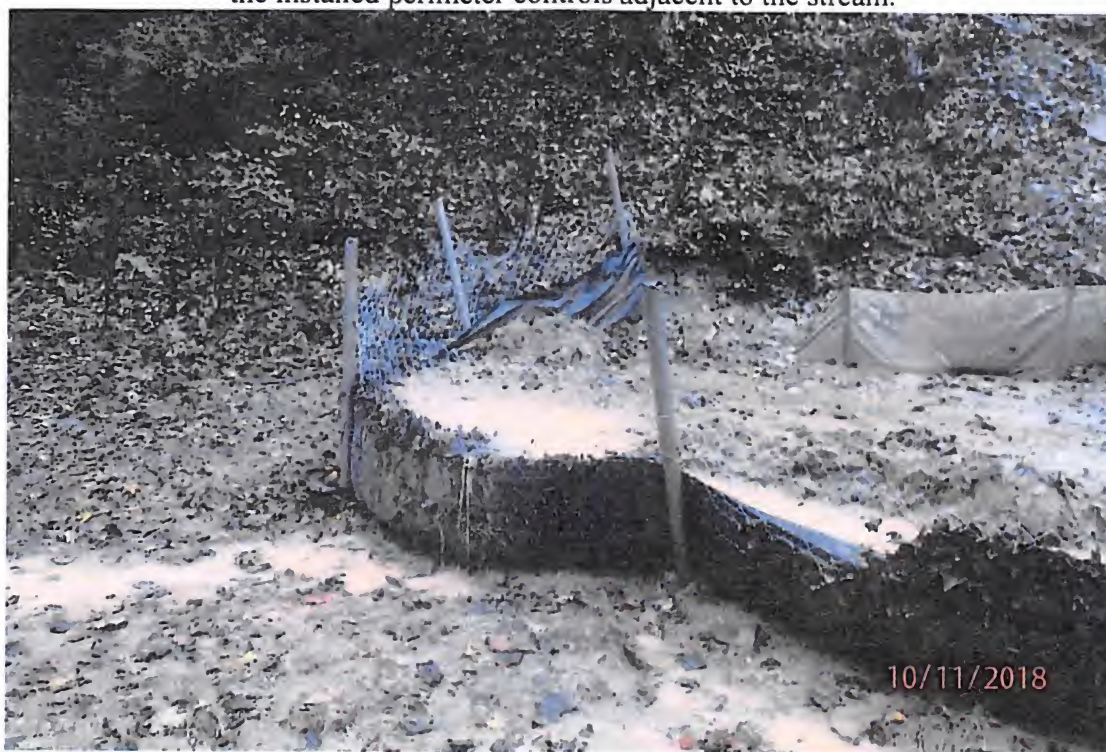
Perimeter controls adjacent to UNT 21 that are overwhelmed from trench water and a lack of maintenance.

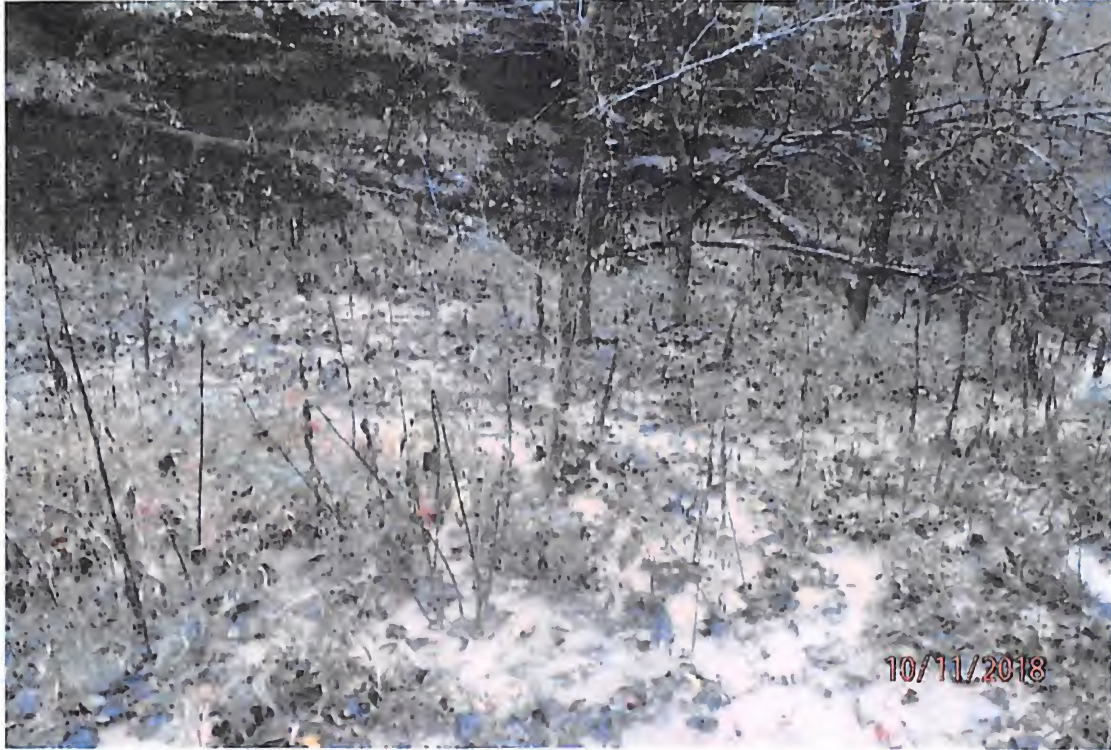
Offsite sediment laden water draining to the receiving stream (UNT 21).

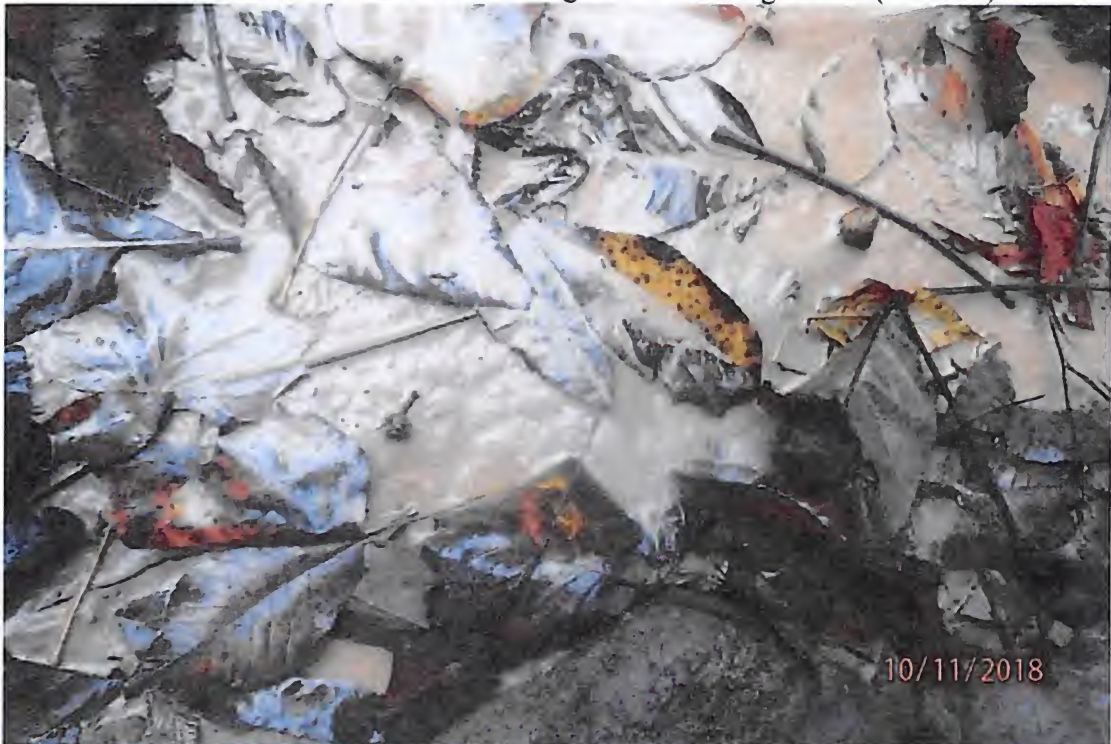
Offsite CNA deposits in UNT Beverlin Fork (UNT 21) (39°26.296' X 80°36.165').

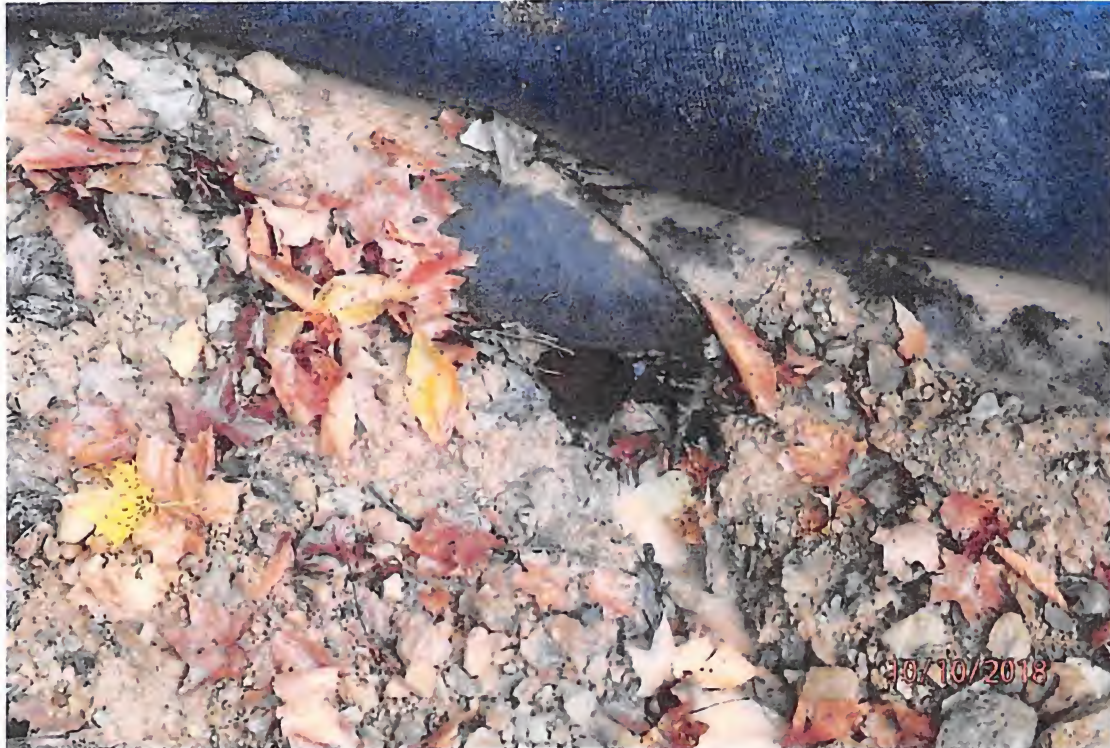
Sediment laden water bypassing under installed water bar terminus BMP adjacent to UNT Riggins Run (39°21.443' X 80°39.489').

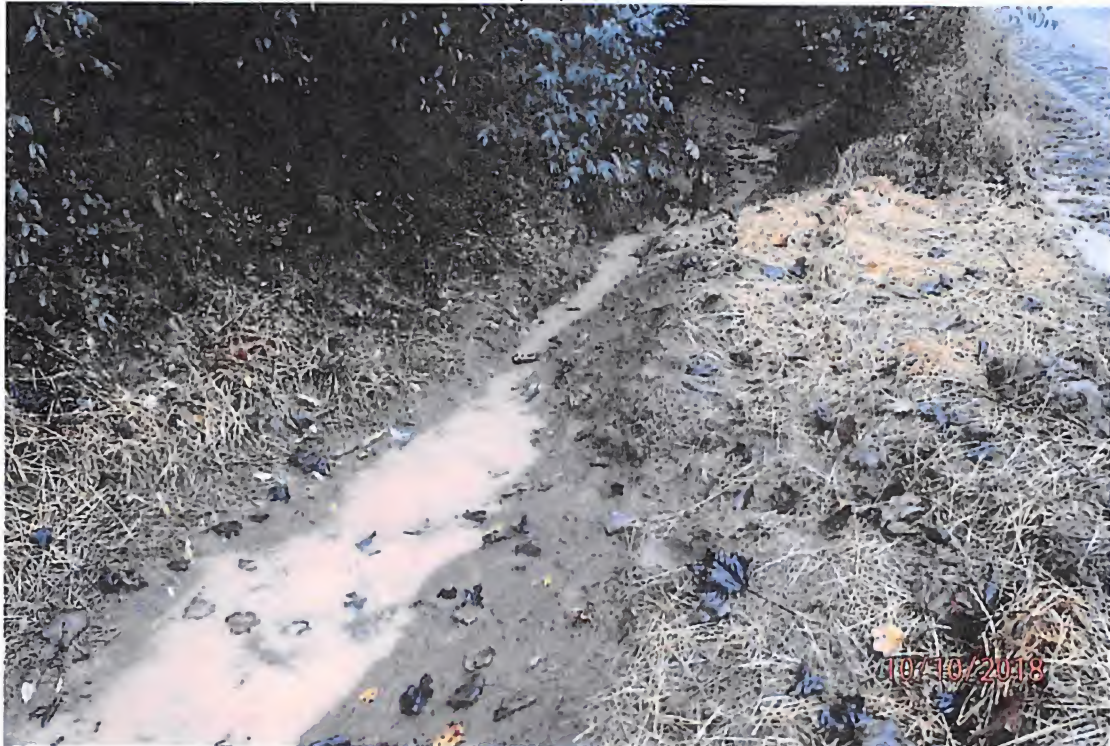
Sediment laden water in diversion along AR 18 going offsite and into UNT Riggins Run (39°21.443' X 80°39.489') contributing to CNA along with previously pictured water bar terminus BMP bypass.

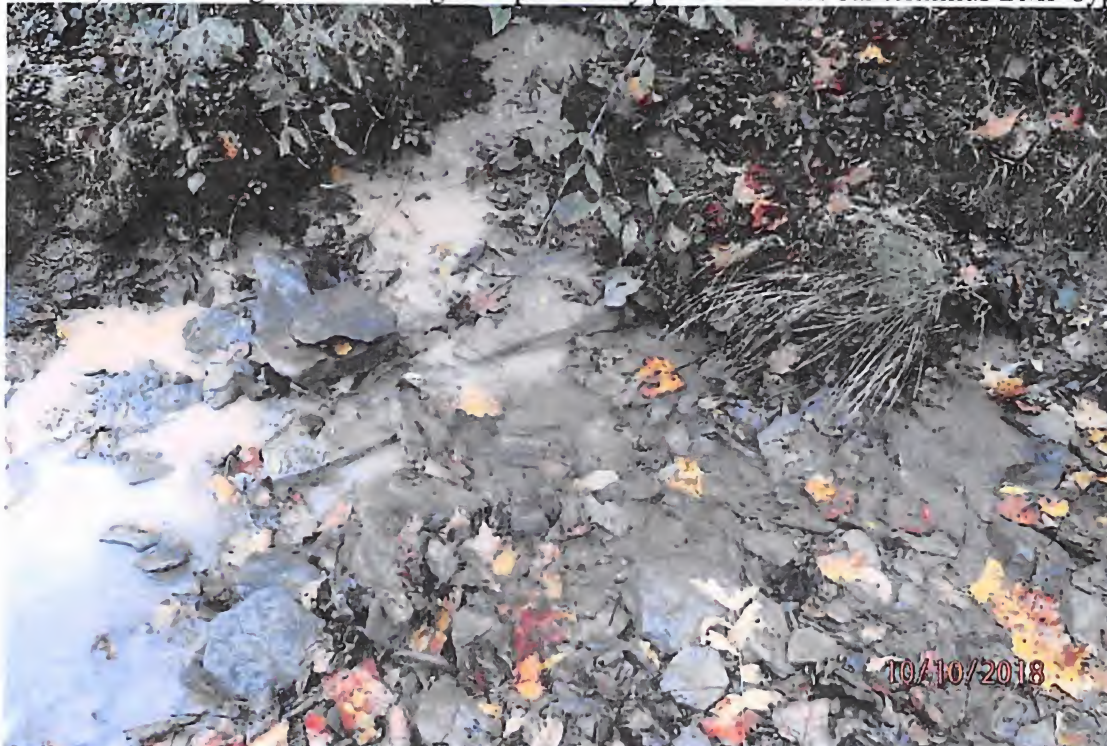
Ephemeral UNT Riggins Run (39°21.443' X 80°39.489') at its convergence with UNT Riggins Run showing distinctly visible plume.

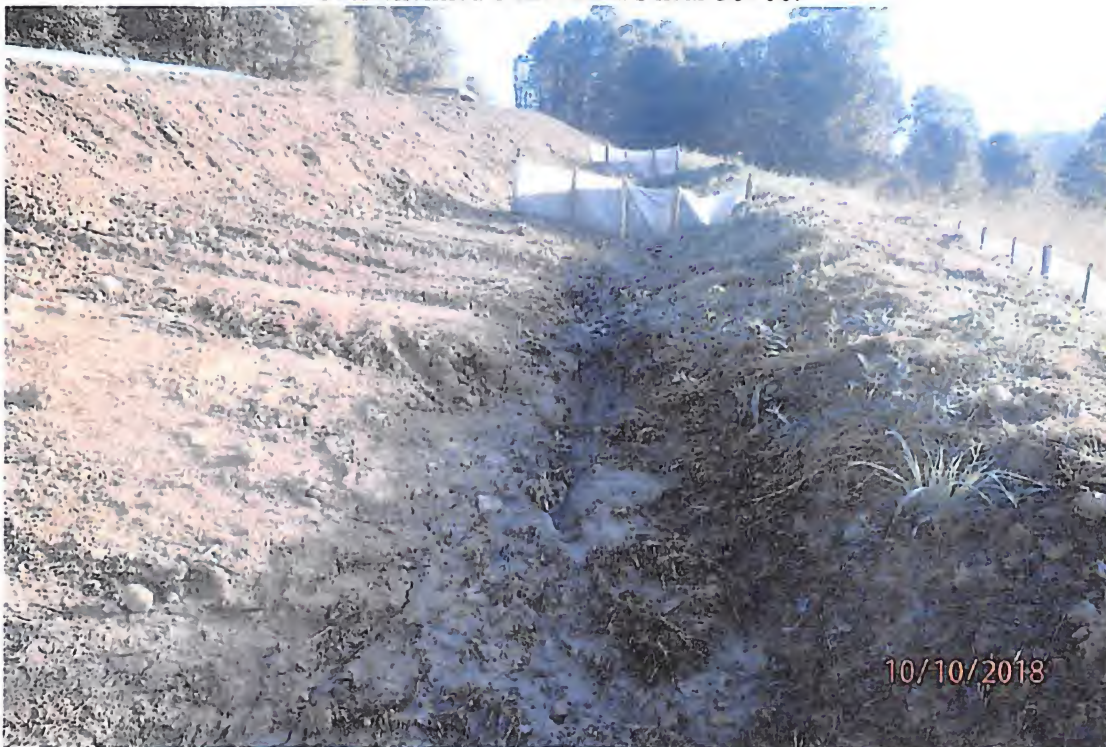
Installed diversion berm that lacks adequate outlets and is causing offsite sediment deposits due to overwhelmed outlet BMPs near 56+00.

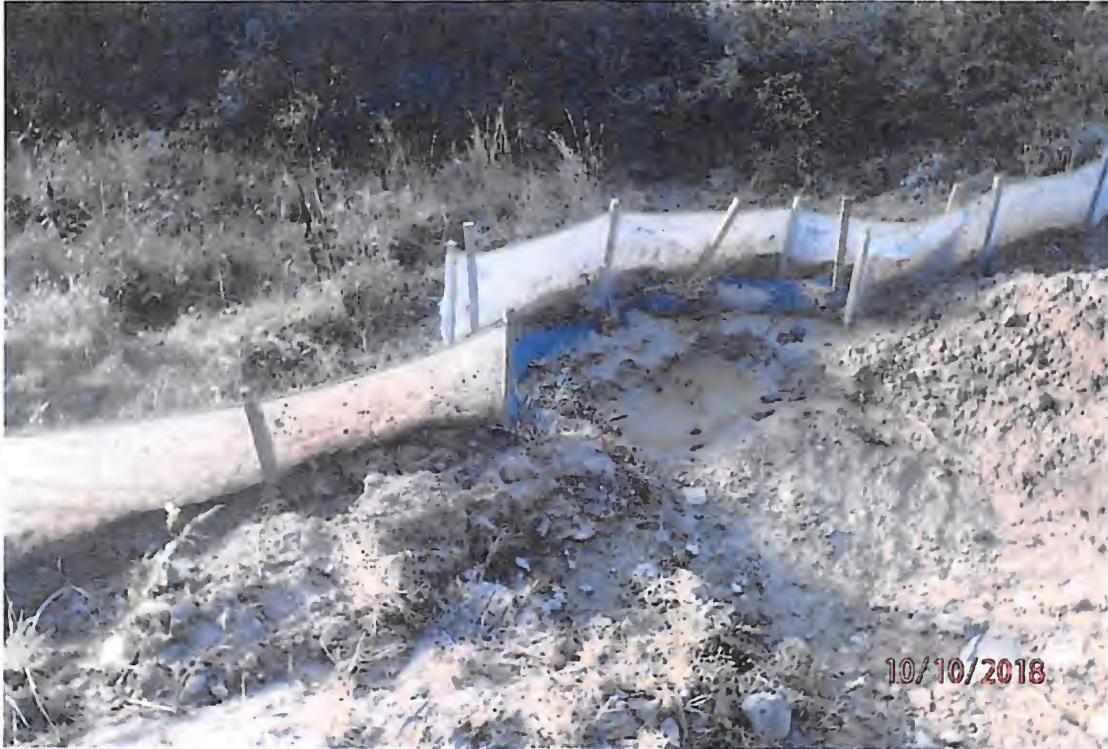
Diversion berm outlet BMP that has been overwhelmed and is in need of maintenance with associated offsite sediment deposits near 56+00.

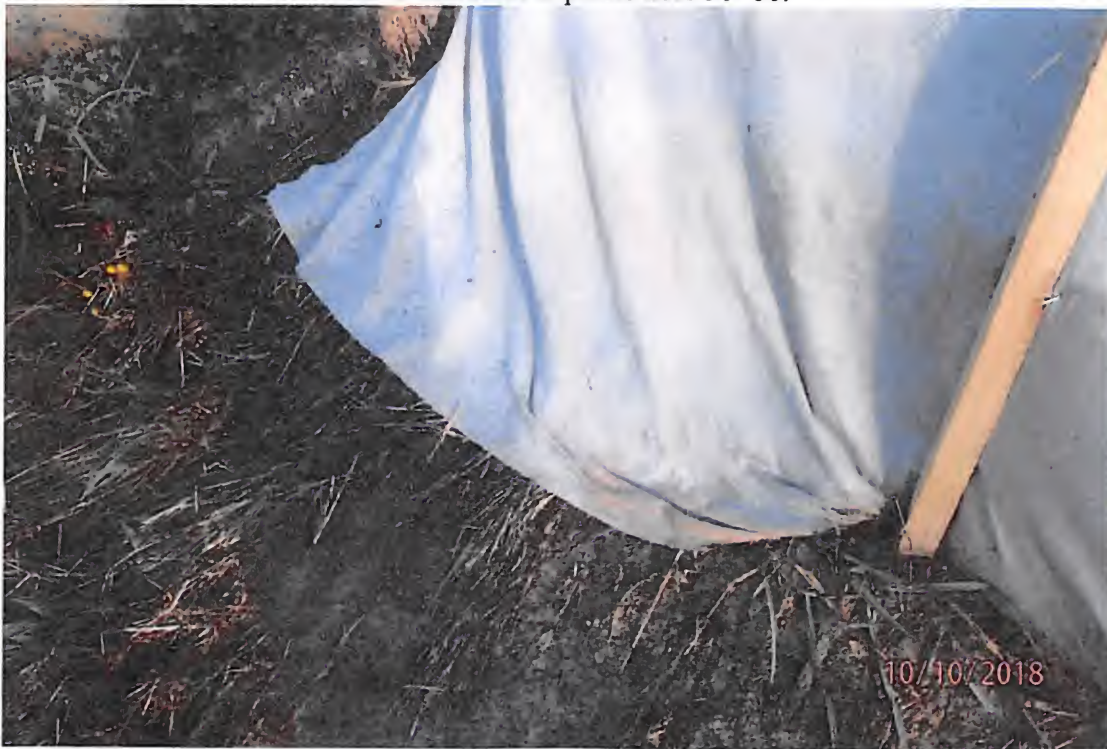
View of above pictured BMP from downslope showing its need for maintenance near 56+00.

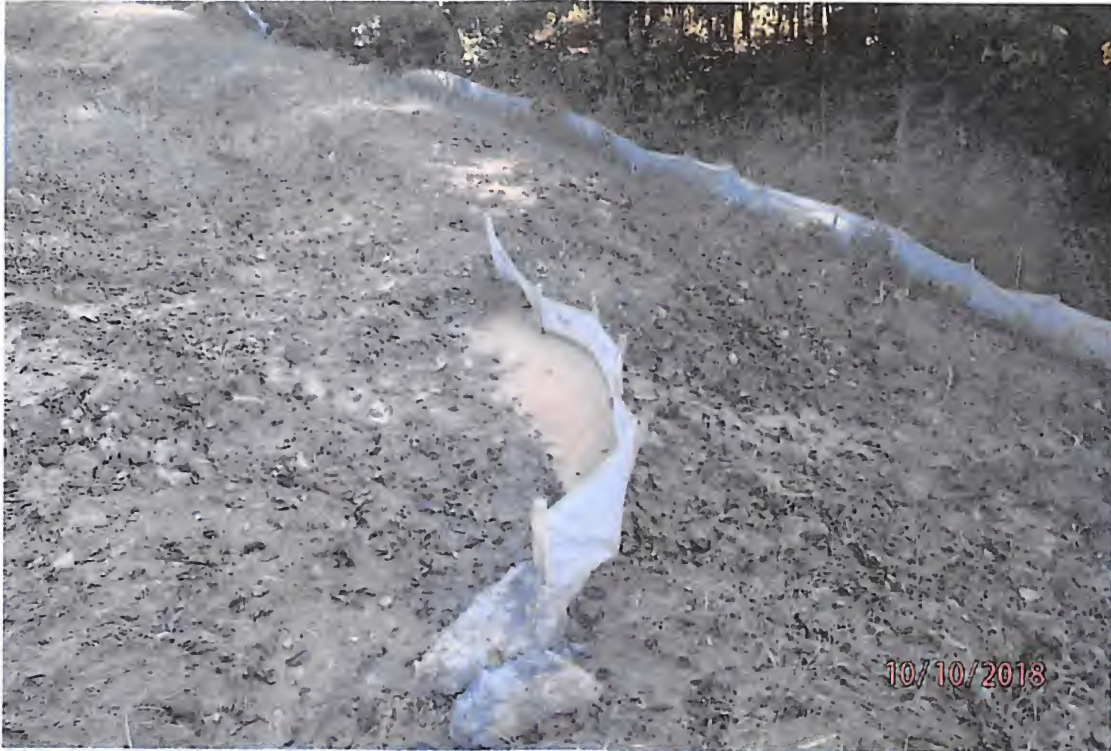
Diversion berm outlet with installed silt fence near 69+00.

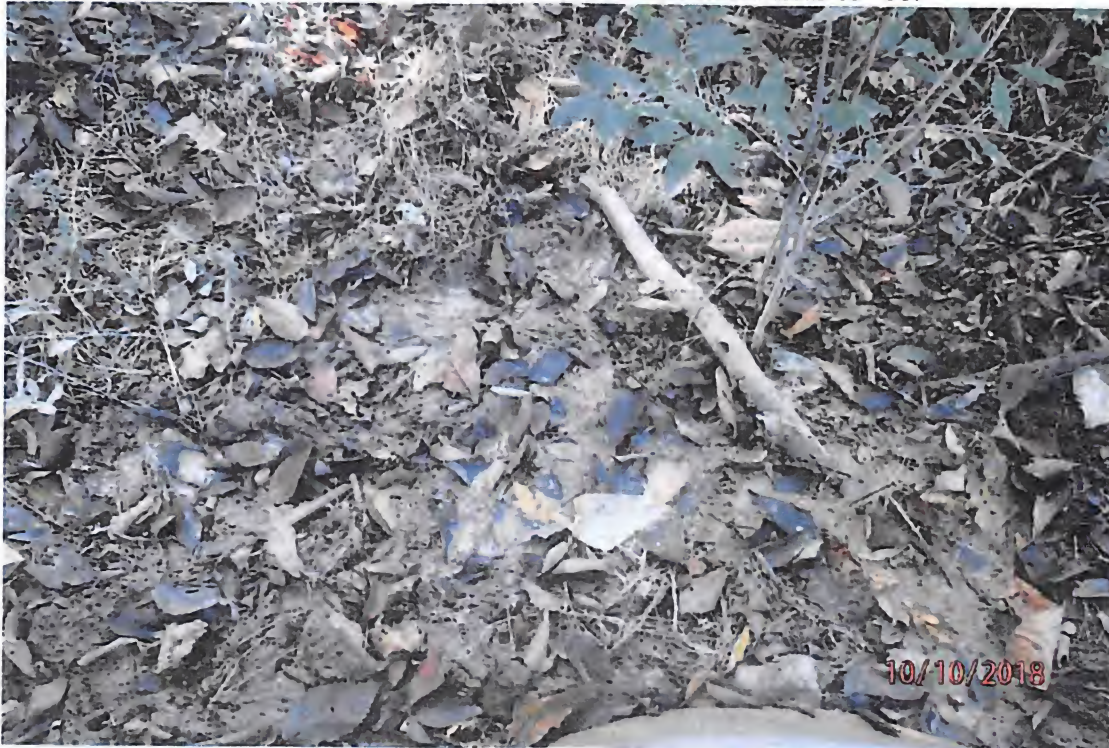
Diversion berm outlet at edge of LOD showing offsite sediment deposits due to poor maintenance and excessive flow being directed at the device near 69+00.

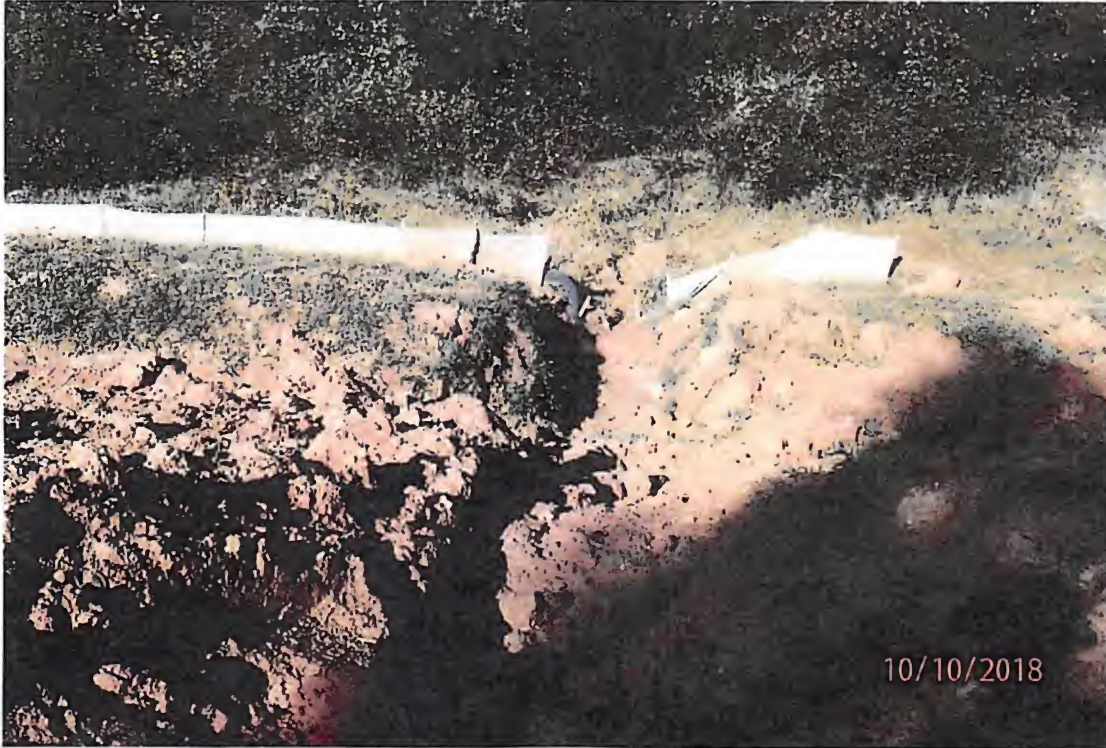
Diversion berm outlet BMP that has been overwhelmed and is in need of maintenance with associated offsite sediment deposits near 132+00.

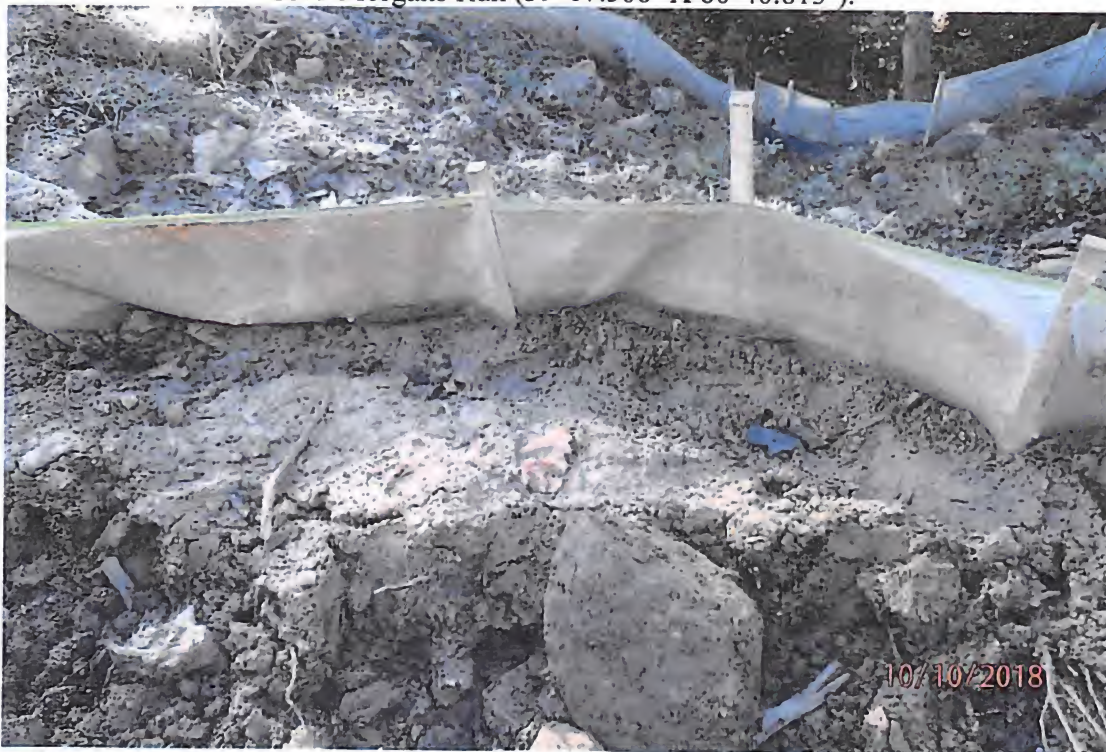
Diversion berm outlet BMP that has been overwhelmed and is associated with offsite CNA deposits near UNT Morgans Run (39°17.506' X 80°40.813').

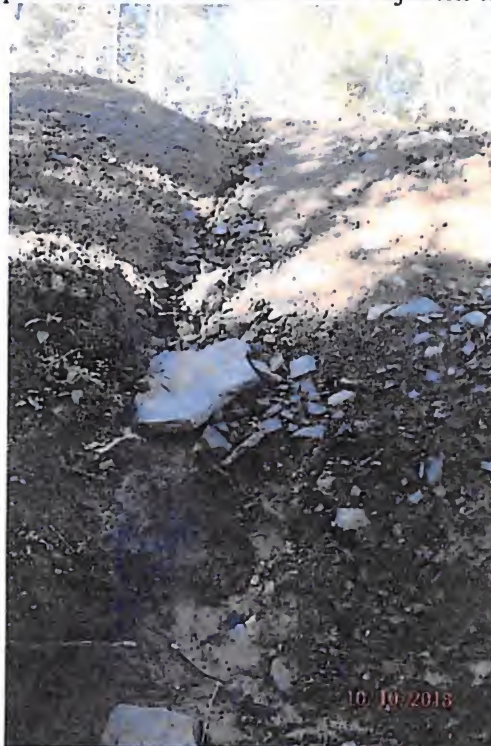
Fill slope erosion at water bar outlet adjacent to 66+00.

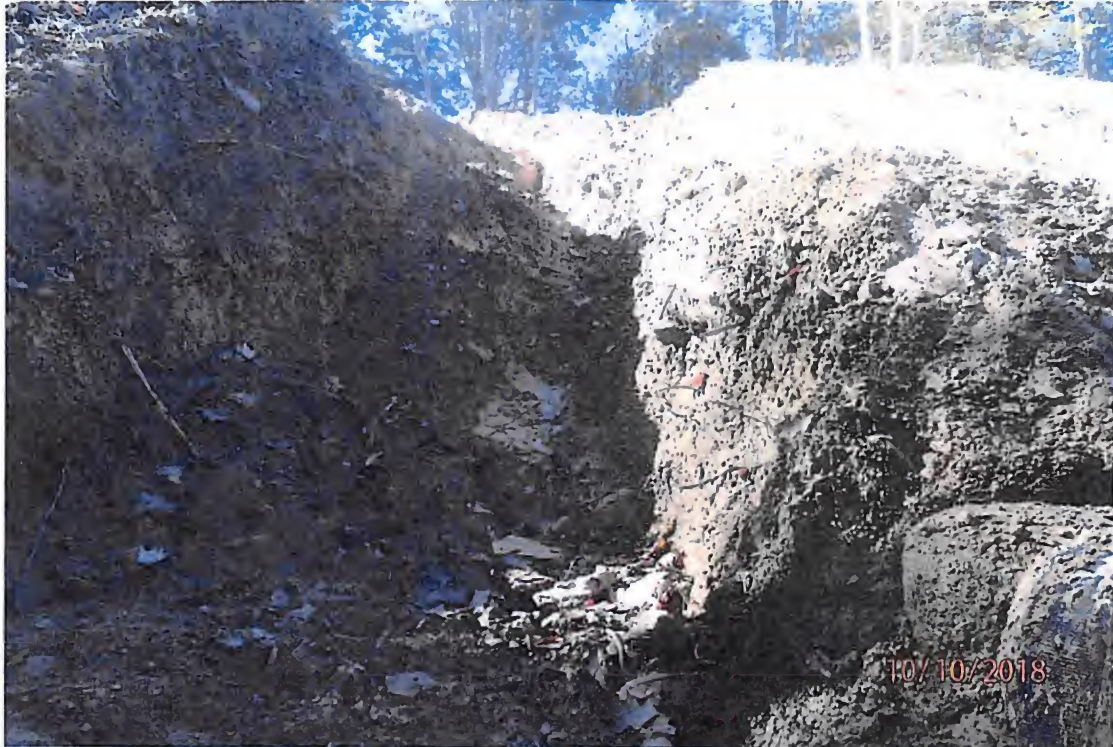
Fill slope erosion at water bar outlet adjacent to 105+00.

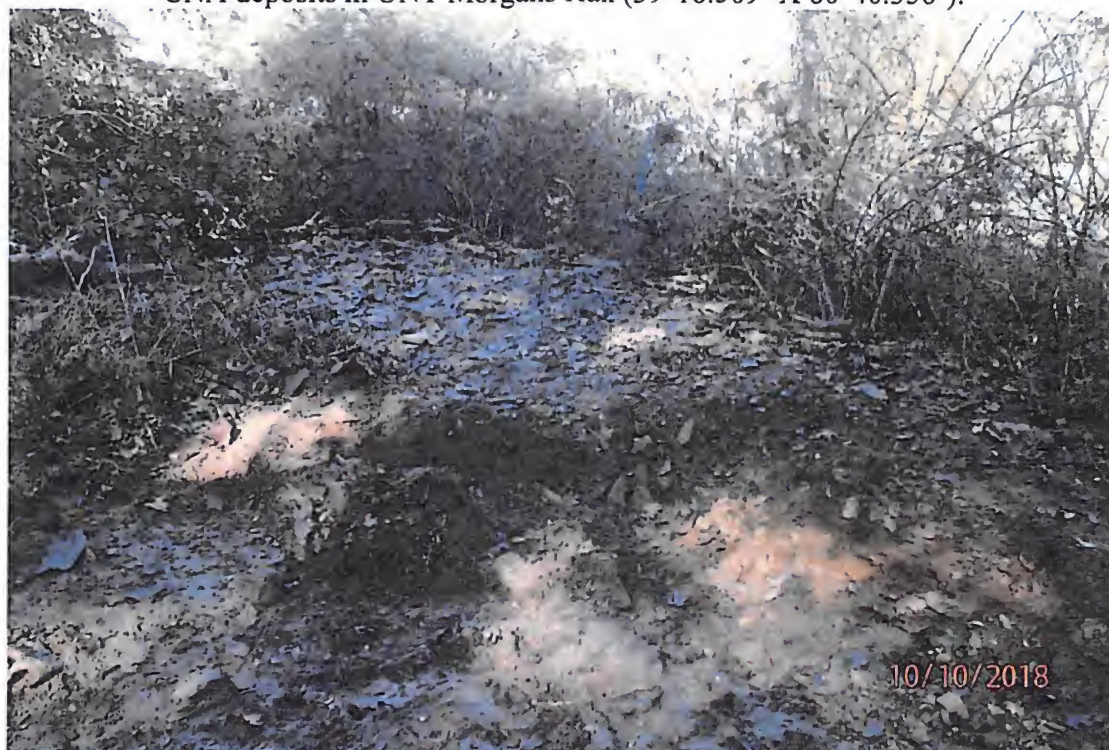
CNA deposits in UNT Morgans Run (39°18.509' X 80°40.356').
